SITE ASSESSMENT

**L. H. INC.
CAMBRIDGE, OHIO**

**WESTON-SPER
Technical Assistance Team
Region V**

August 1988

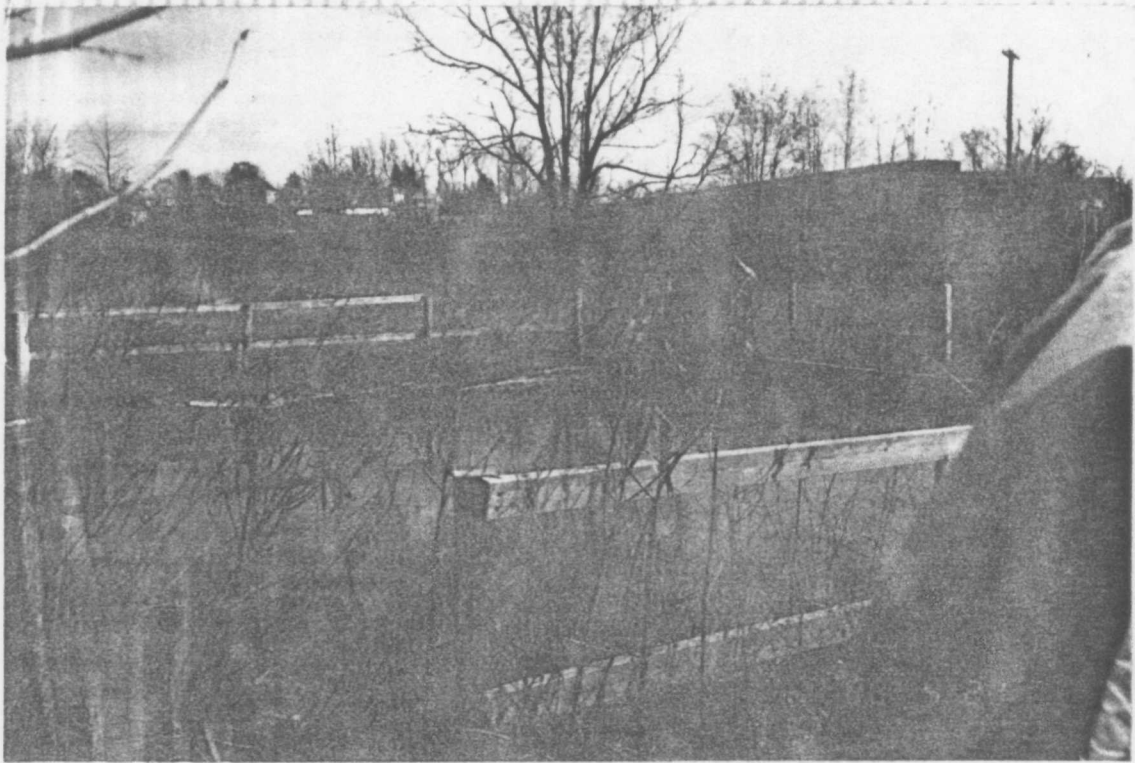
Each of the three lagoons covered an area of approximately 1,120 ft², was 5 ft in depth, and held approximately 40,000 gallons of treated waste product. A deteriorating wooden-plank fence 3 ft in height surrounded each lagoon. The lagoons were lined with thick, rubber liners to prevent leaching of treated wastes into the underlying soil. The area surrounding the lagoons was heavily vegetated with shrubs and grasses. All three lagoons contained a semi-murky liquid. Freeboard ranged from 4 to 12 inches in each lagoon.

PHOTO NUMBER 1
 Roll 1, Photo 1
 L.H. Inc., Cambridge, Ohio
 View to the southeast over Lagoon 2.
 Wooden retaining fence is deteriorating.
 (Photo by Stanifer, 4/21/88) EES

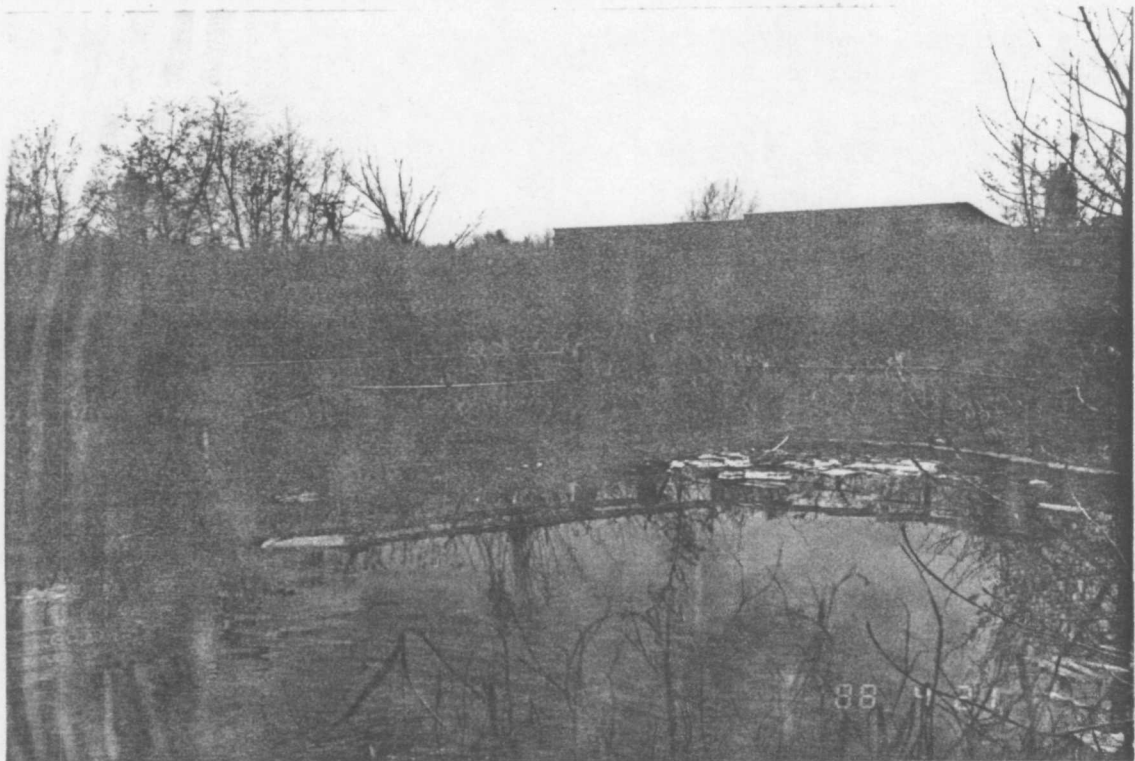
PHOTO NUMBER 2
 Roll 1, Photo 2
 L.H. Inc., Cambridge, Ohio
 View to the southeast over Lagoon 1.
 Lagoon 2 and Sunstone Pottery in background.
 (Photo by Stanifer, 4/21/88) EES

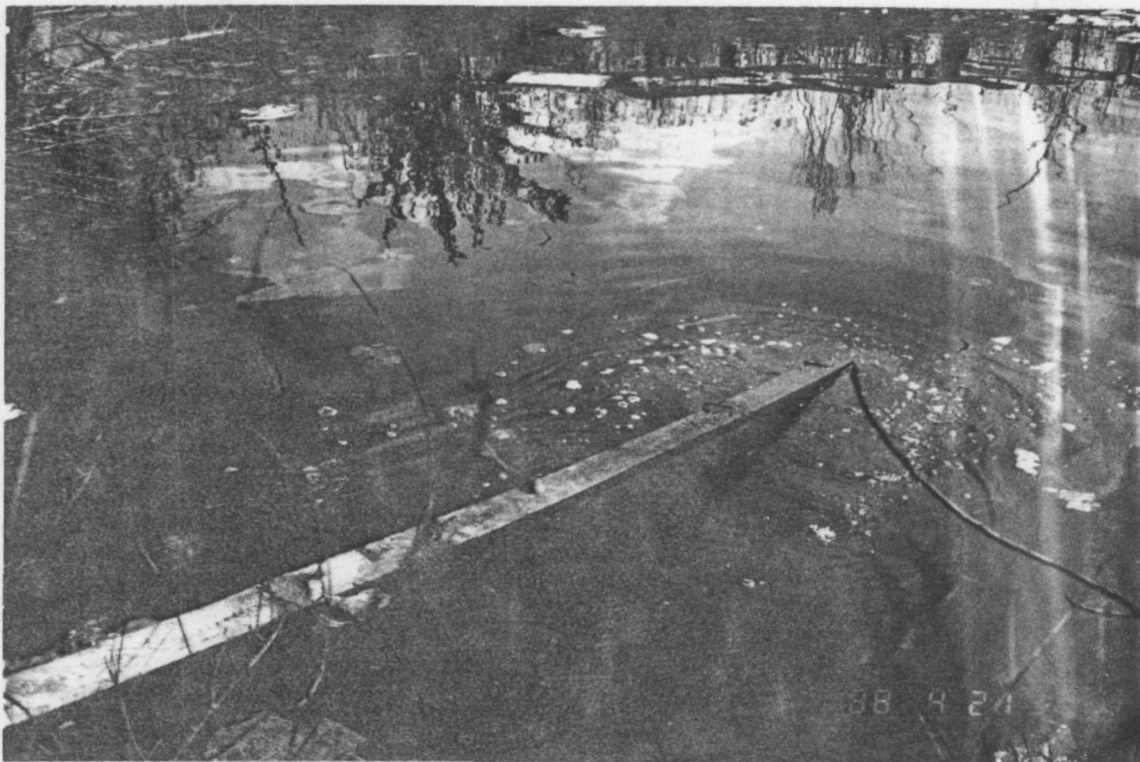
During the site inspection, a reddish-orange sludge on the bottom of Lagoon 1 was stirred to the surface by the TAT; however, no sludge could be stirred to the surface in either Lagoon 2 or 3. Sludge produced by a lime treatment of spent pickle liquor constitute U.S. EPA listed Hazardous Waste, No. K063 (40 CFR Part 261.32). Liquid and sludge in the lagoons registered between 7 and 10 on pH indicator strips. At the surface, the lagoon liners appeared to be intact. No tears, holes, or abraded surfaces were evident on the exposed parts of the liners. The part of the liners containing the liquids and sludges are assumed to be intact. No effort was made to excavate soil or to check the subsurface integrity of the liners because of the potential of causing contaminant migration.

PHOTO NUMBER 3
 Roll 1, Photo 3
 L.H. Inc., Cambridge, Ohio
 Sludge being stirred from bottom of Lagoon 1.
 (Photo by Stanifer, 4/21/88) EES

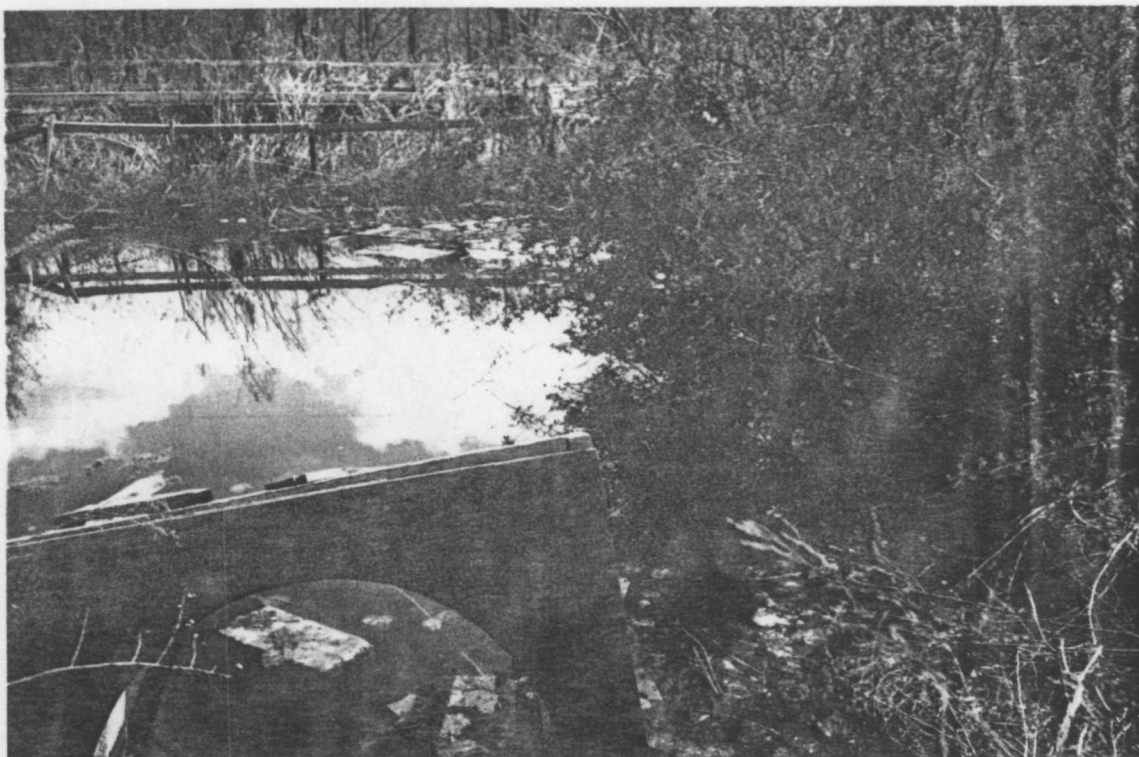
PHOTO NUMBER 4
 Roll 1, Photo 4
 L.H. Inc., Cambridge, Ohio
 Vegetation and debris along edges of Lagoon 1.
 Lagoon 2 in background. View to the east.
 (Photo by Stanifer, 4/21/88) EES

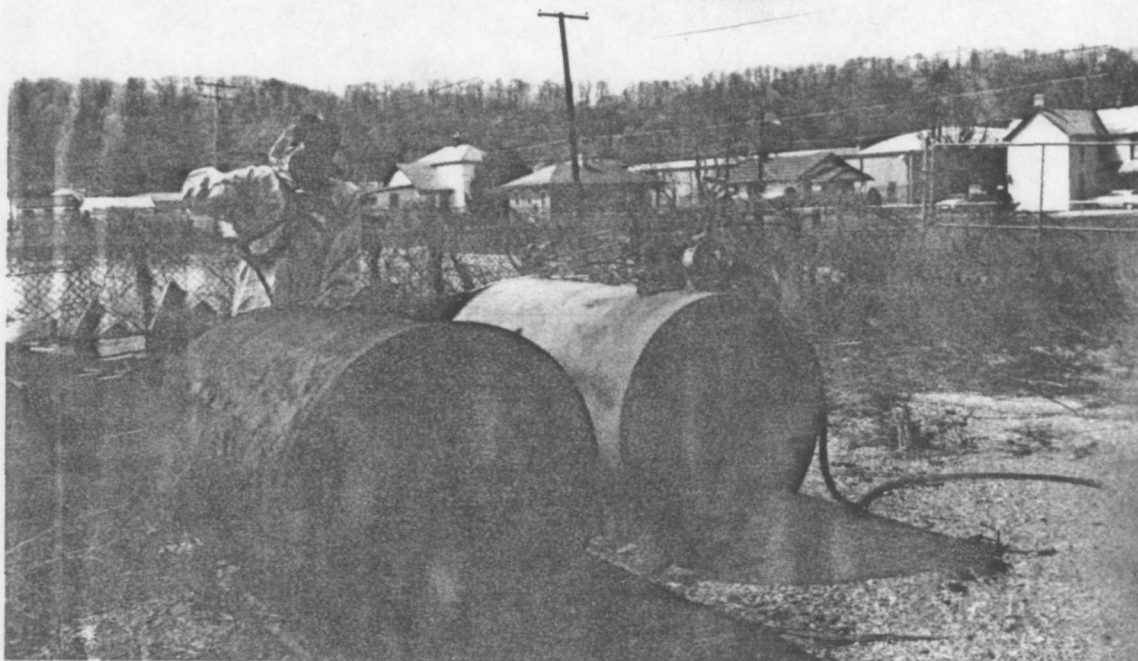
Midway between Building 1 and the southern edge of the property two 300-gallon capacity fuel tanks were observed. Both tanks were measured and found to be approximately half full. Air monitoring readings taken inside the tank openings indicated the presence of an organic-based liquid, which was likely to be some type of fuel.

A Thyvac III Radiation Meter, HNU Systems Photoionization Analyzer, MSA Combustible Gas Indicator, and hydrogen cyanide and hydrogen sulfide Monitox units were used by the TAT to perform air monitoring during the site inspection. All readings remained at background levels except those recorded inside the two 300-gal capacity fuel tanks. HNU readings inside these two tanks registered up to 250 units.

PHOTO NUMBER 5
 Roll 1, Photo 5
 L.H. Inc., Cambridge, Ohio
 TAT Scoville measuring depth of liquid in
 300-gal tank. View to the southwest from Lagoon 1.
 Residential area in background.
 (Photo by Stanifer, 4/21/88) EES

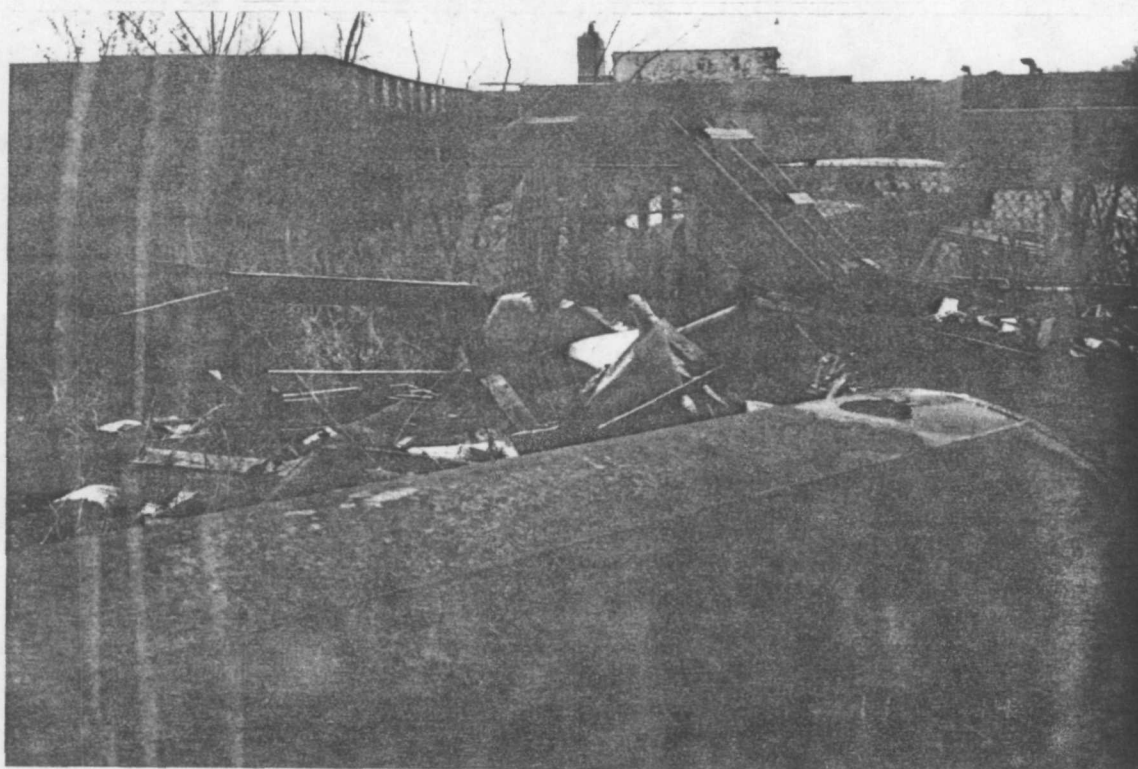
PHOTO NUMBER 6
 Roll 1, Photo 6
 L.H. Inc., Cambridge, Ohio
 View to the south from 300-gal storage
 tank next to Lagoon 1. Sunstone Pottery
 in background.
 (Photo by Stanifer, 4/21/88) EES

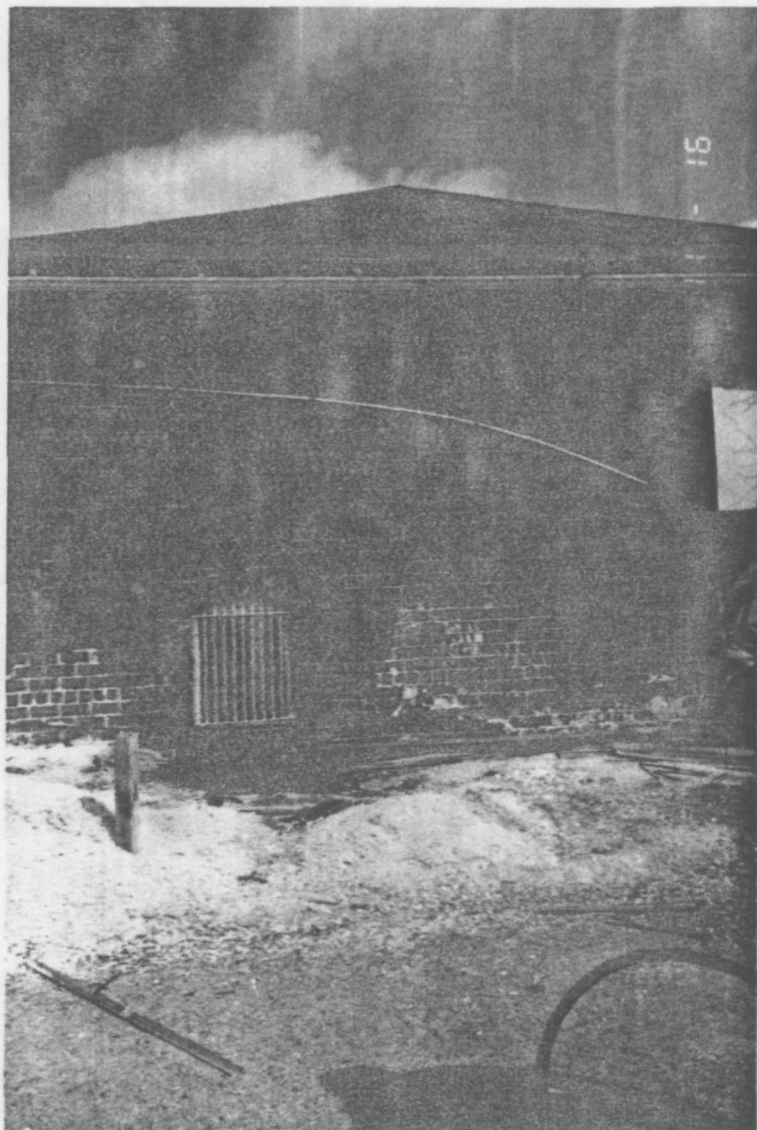
PHOTO NUMBER 7
Roll 1, Photo 7
L.H. Inc., Cambridge, Ohio
View of lime pile at base of building
next to Lagoon 3 (looking north).
(Photo by Stanifer, 4/21/88) EES

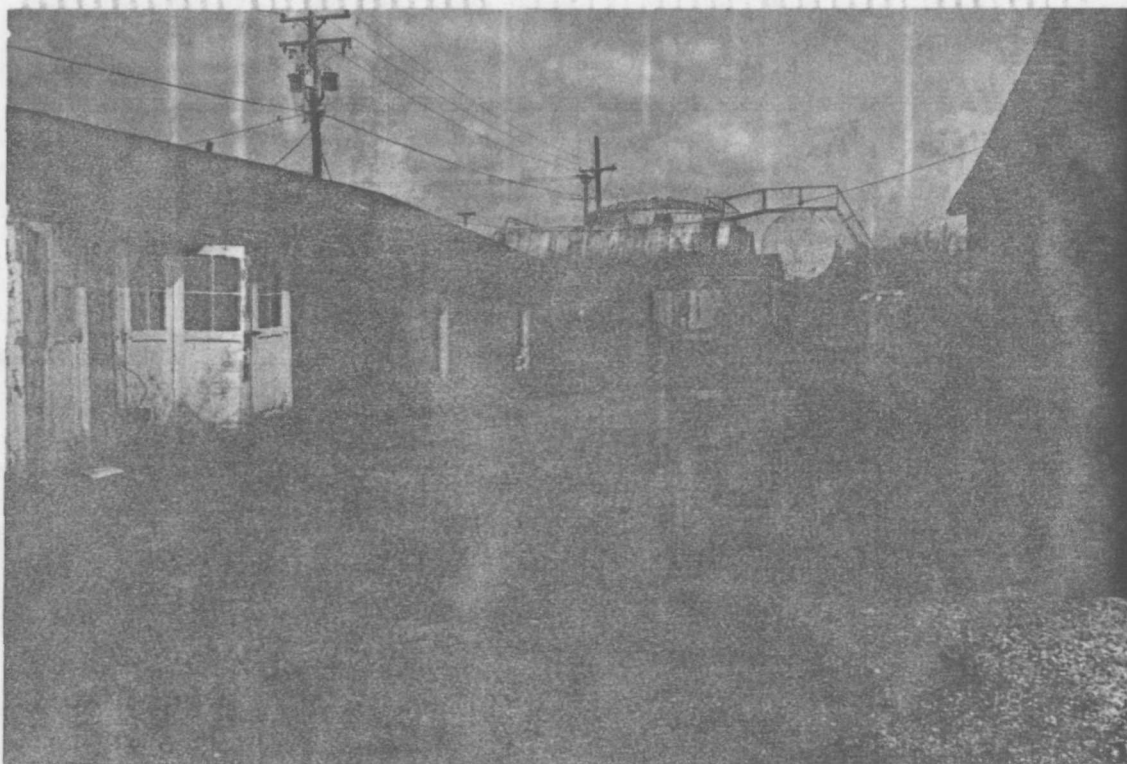
Four 10,000-gal-capacity horizontal fuel storage tanks were located approximately 30 ft north of Building 2. The four tanks rested on their sides on top of several 10-ft-high brick wall supports. Adjacent to the four tanks was a 20,000-gal-capacity, vertical storage tank. According to the OEPA representative, Mr. Poorman, these five tanks had been previously checked and found to be empty.

PHOTO NUMBER 8
 Roll 1, Photo 8
 L.H. Inc., Cambridge, Ohio
 View of storage tanks and buildings 1 and 2
 located west and northwest of the lagoons.
 (Photo by Stanifer, 4/21/88) EES

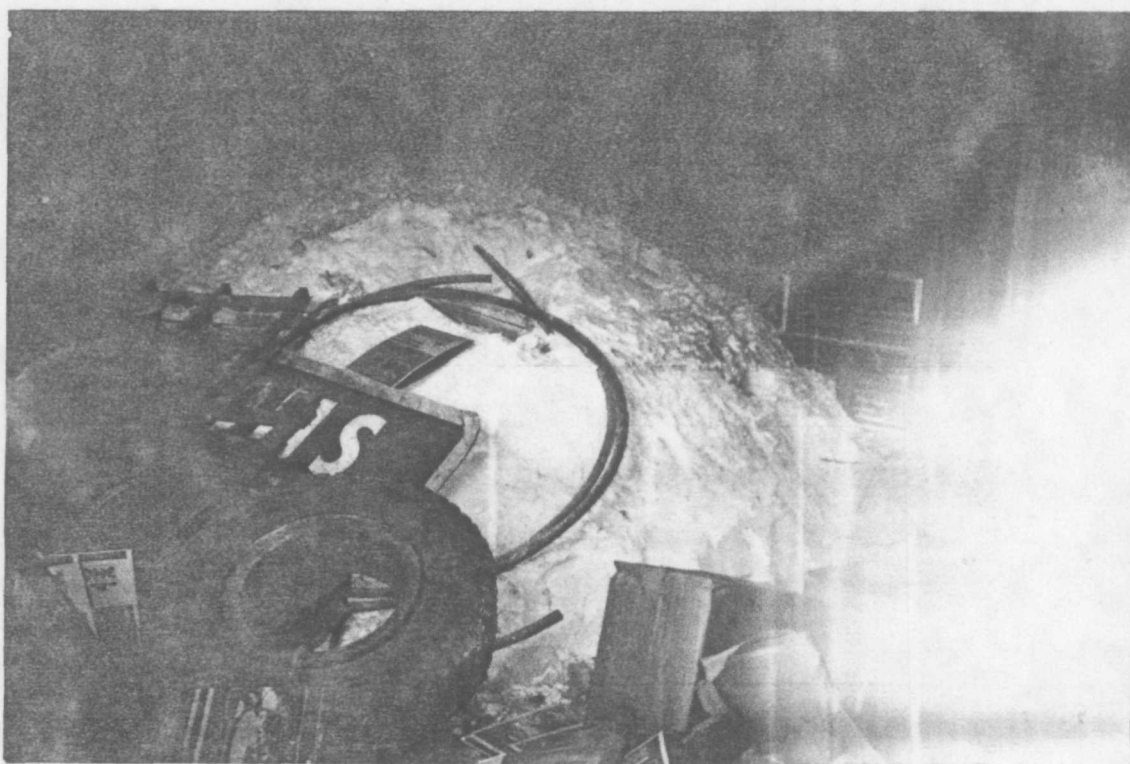
building (Building 2) were also boarded, but several sets of garage doors in this building were left open. A large pile (approximately 21 yd³) of lime was observed in a storage area of Building 2. This material may have been used to treat the acidic pickle liquor.

PHOTO NUMBER 9
 Roll 1, Photo 9
 L.H. Inc., Cambridge, Ohio
 View of lime pile inside storage building 2.
 (Photo by Stanifer, 4/21/88) EES

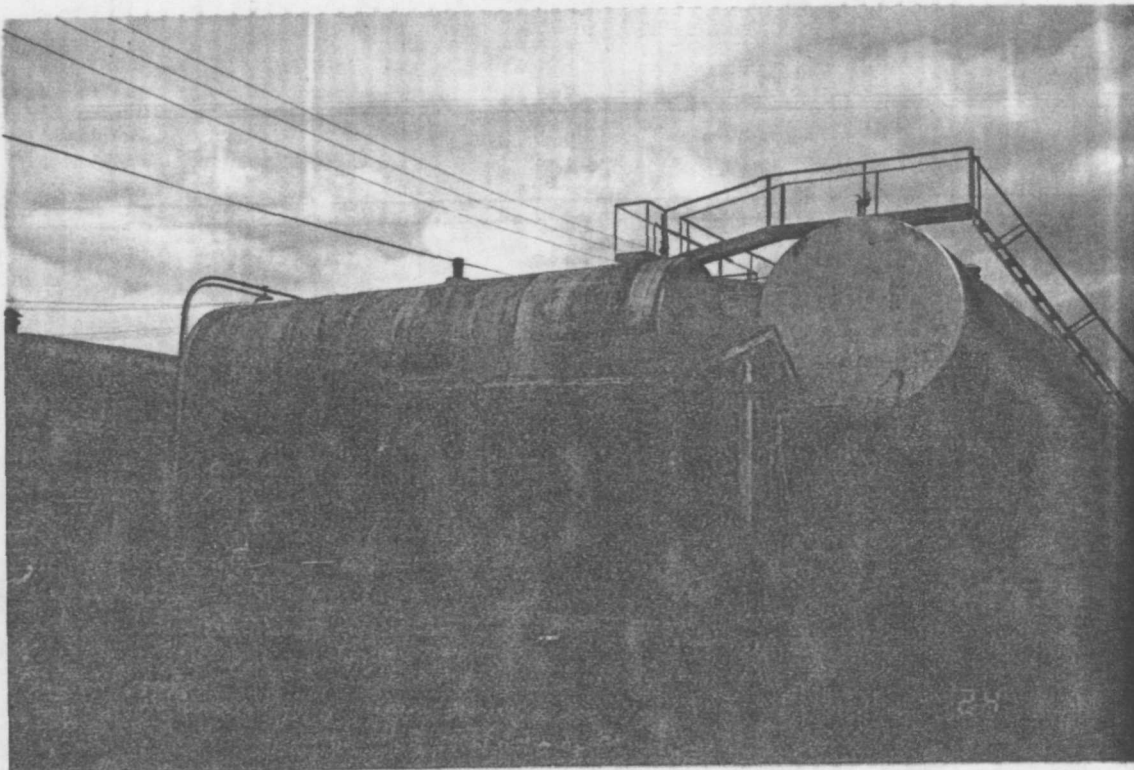
PHOTO NUMBER 10
 Roll 1, Photo 10
 L.H. Inc., Cambridge, Ohio
 View of fuel loading dock and metal storage tanks.
 (Photo by Stanifer, 4/21/88) EES

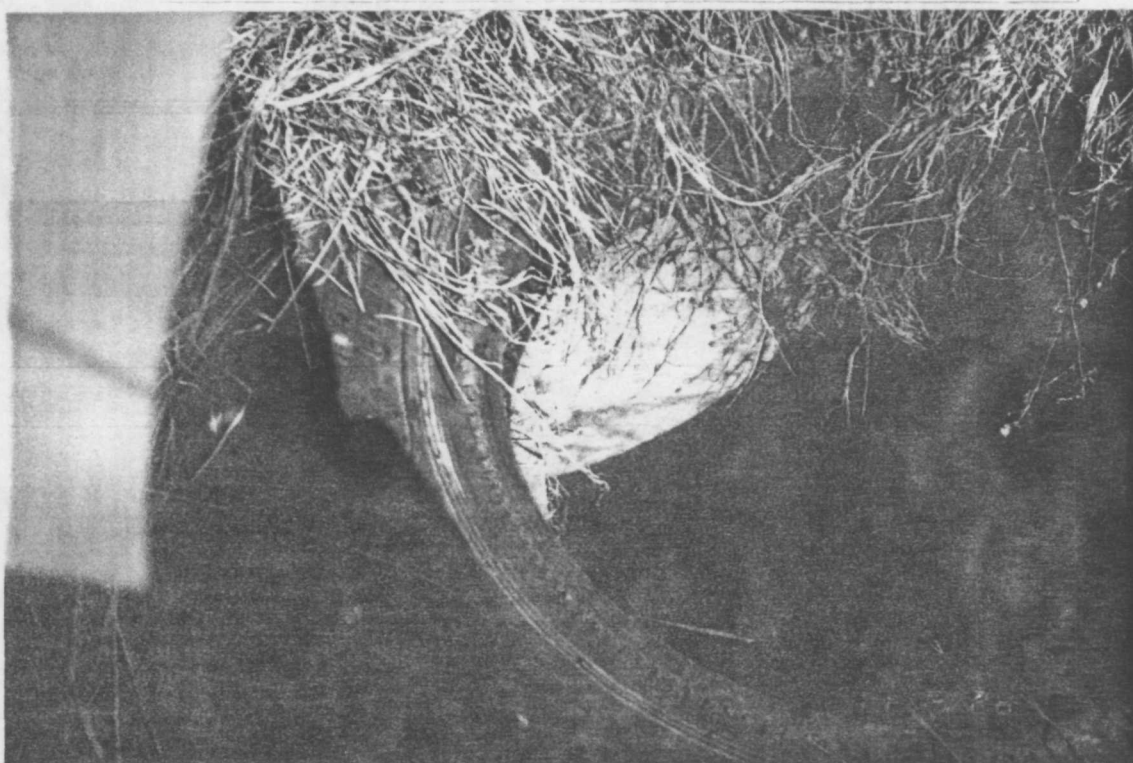
PHOTO NUMBER 11
 Roll 1, Photo 11
 L.H. Inc., Cambridge, Ohio
 View of drain leading to Cambridge sewer system.
 Drain is located approximately 15 ft north of
 Lagoon 3. Truck tire protects drain surface.
 (Photo by Stanifer, 4/21/88) EES

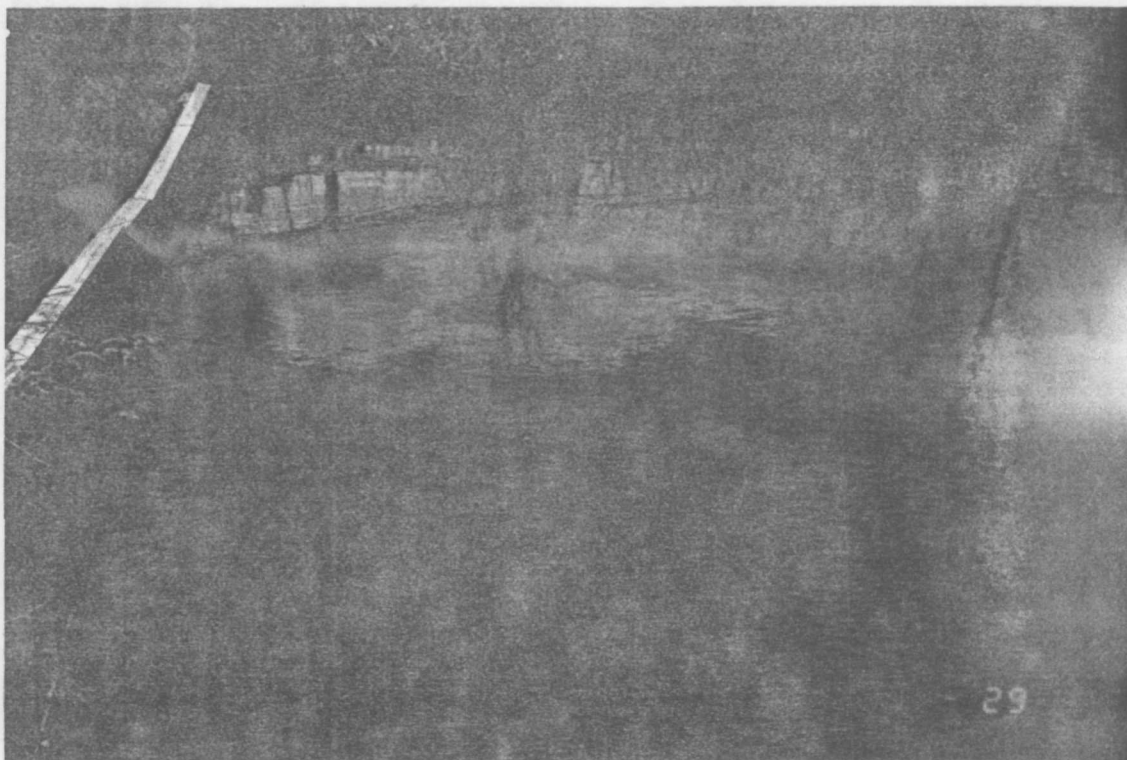
PHOTO NUMBER 13
 Roll 1, Photo 13
 L.H. Inc., Cambridge, Ohio
 Surface view of Lagoon 3.
 (Photo by Stanifer, 4/21/88) EES

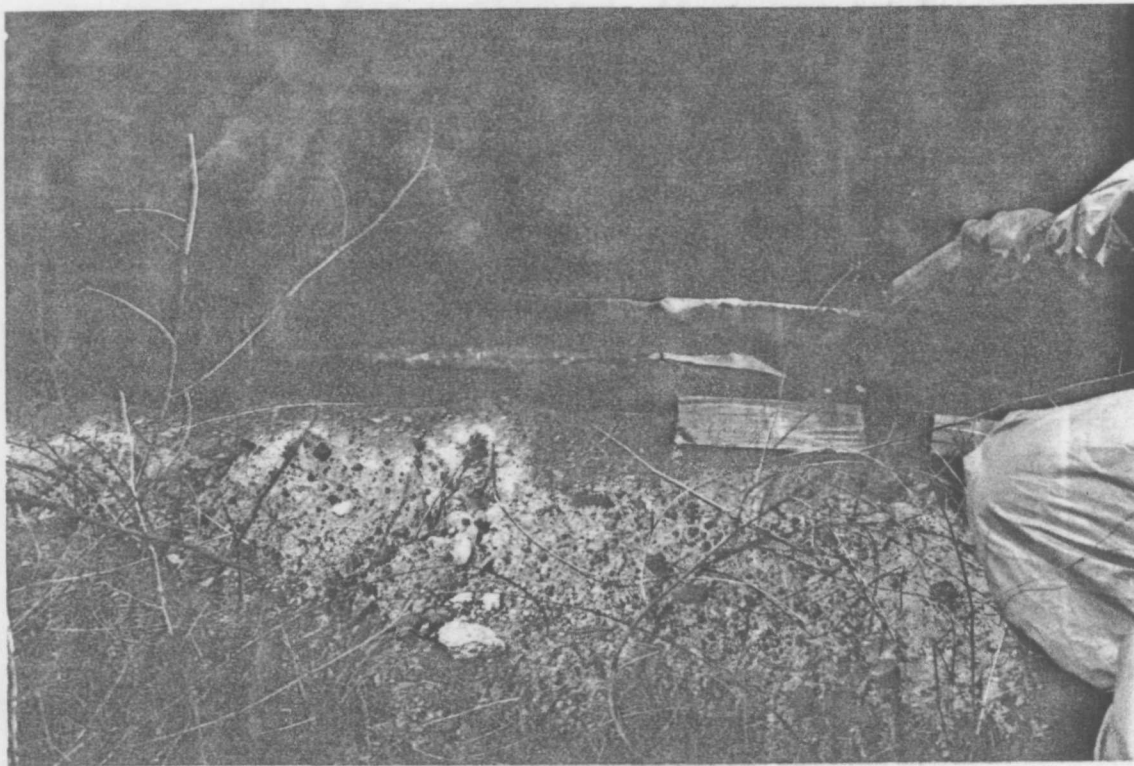
PHOTO NUMBER 14
 Roll 1, Photo 14
 L.H. Inc., Cambridge, Ohio
 View of liner and soil along Lagoon 3.
 (Photo by Stanifer, 4/21/88) EES

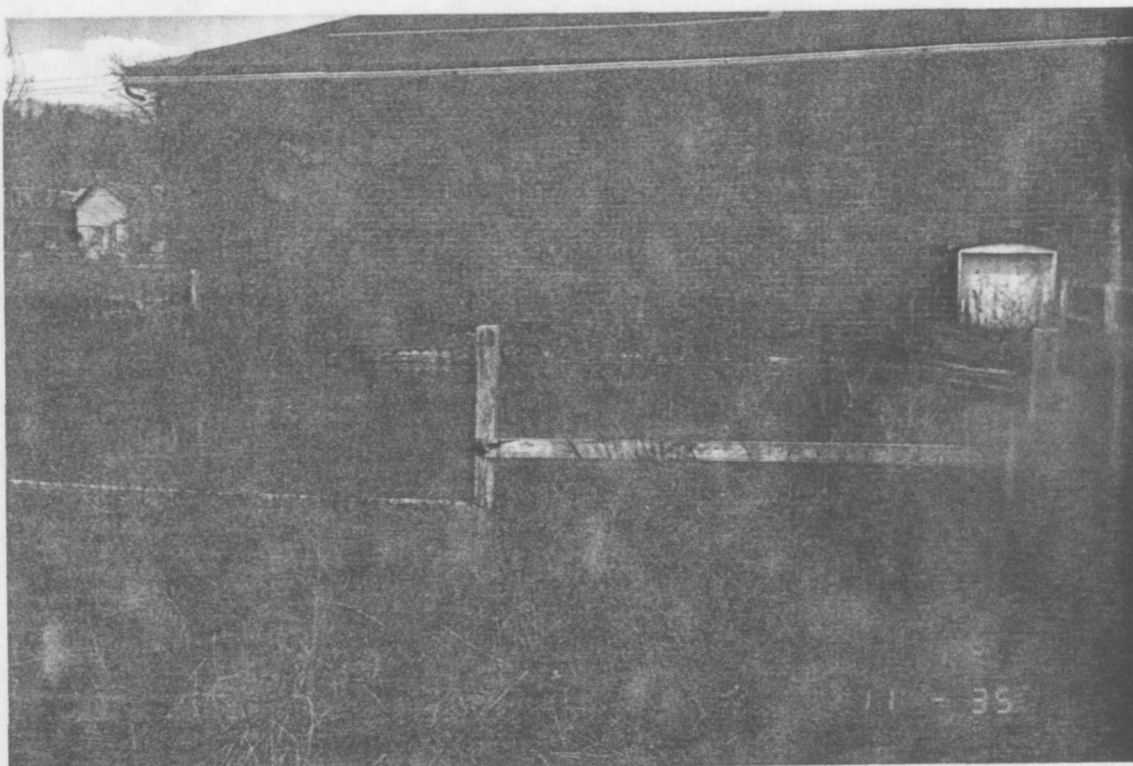
PHOTO NUMBER 16
 Roll 1, Photo 16
 L.H. Inc., Cambridge, Ohio
 View of Lagoon 3. Building 1 in background.
 Looking to the west.
 (Photo by Stanifer, 4/21/88) EES

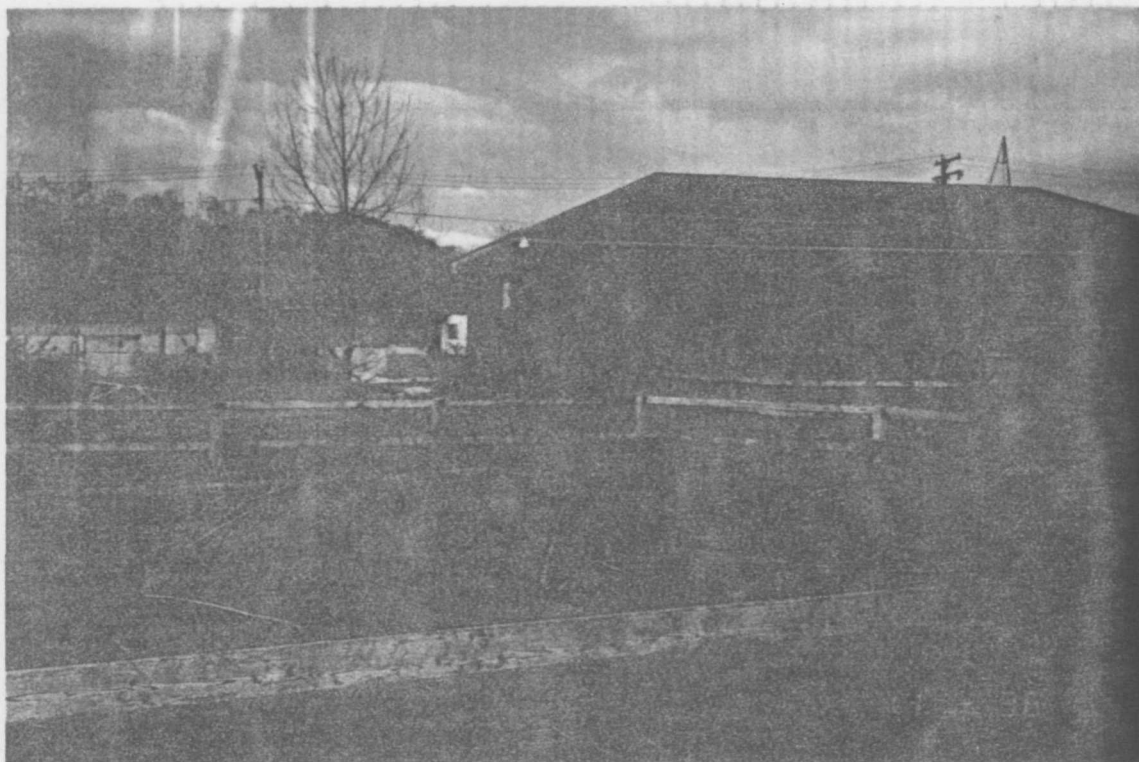
PHOTO NUMBER 17

View of Lagoon 2. Lagoons 1 and 3, storage buildings
and 300-gal storage tanks in background.
